Pictorial review

Artefacts found in computed radiography

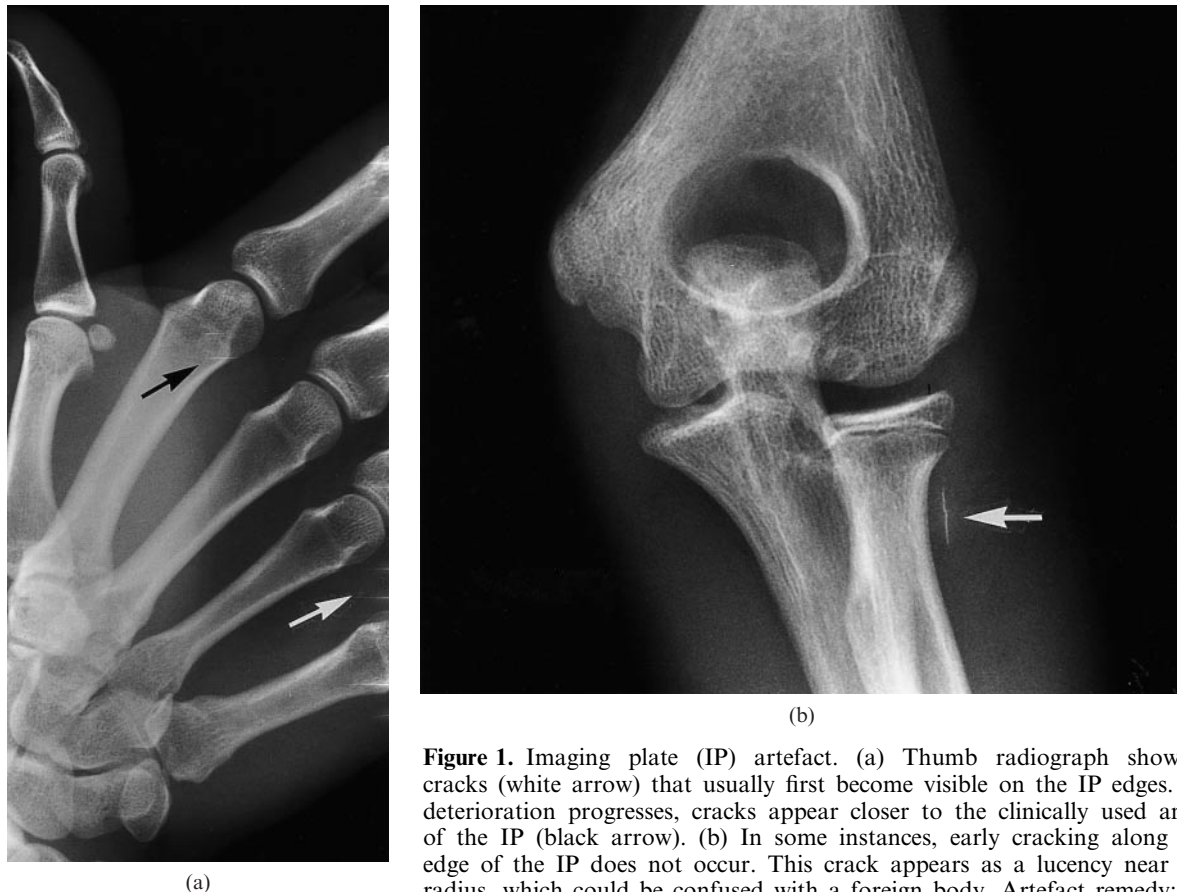
Figure 1. Imaging plate (IP) artefact. (a) Thumb radiograph showing cracks (white arrow) that usually first become visible on the IP edges. As deterioration progresses, cracks appear closer to the clinically used areas of the IP (black arrow). (b) In some instances, early cracking along the edge of the IP does not occur. This crack appears as a lucency near the radius, which could be confused with a foreign body. Artefact remedy: an IP must be replaced when cracks occur in clinically useful areas.

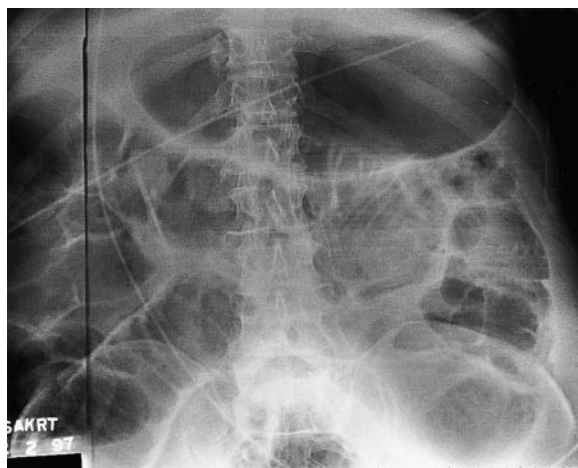
Figure 3. Imaging plate artefact. The dark line along the lateral portion of this upper abdomen is caused by backscatter transmitted through the back of the cassette. The line corresponds to the cassette hinge where the lead coating was weakened or cracked. Artefact remedy: to reduce backscatter, the radiographer should collimate when possible. Since backscatter cannot be eliminated in every case, knowledge of the radiographic appearance of cassette backs is useful.

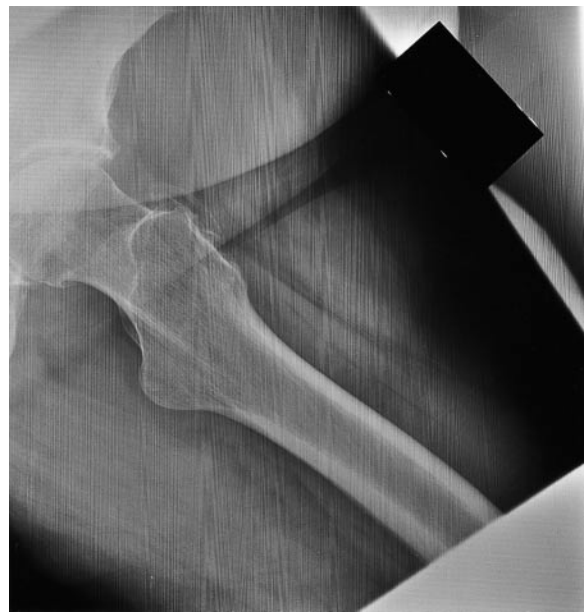
Figure 4. Plate reader artefact. The pattern of lines seen on this oblique hip view occurred intermittently. The artefact was traced to the plate reader's electronics. Artefact remedy: the electronic board that controlled the photomultiplier tube was replaced.

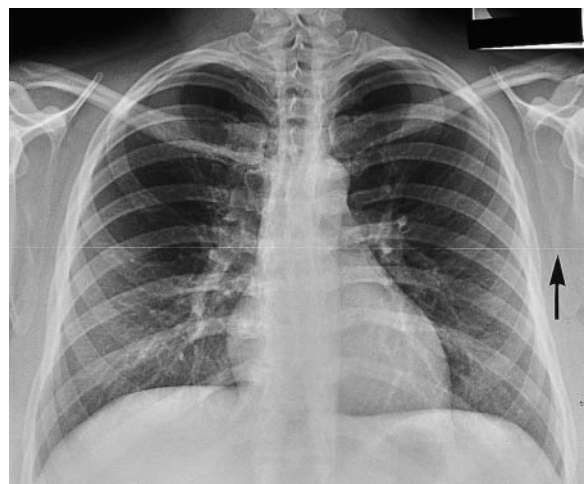
Figure 5. Plate reader artefact. The horizontal white line (arrow) shown on this upright chest radiograph was caused by dirt on the light guide in the plate reader. The light guide collects light emitted from the imaging plate when it is scanned by the laser. Artefact remedy: the light guide of the photomultiplier tube was cleaned by service personnel.

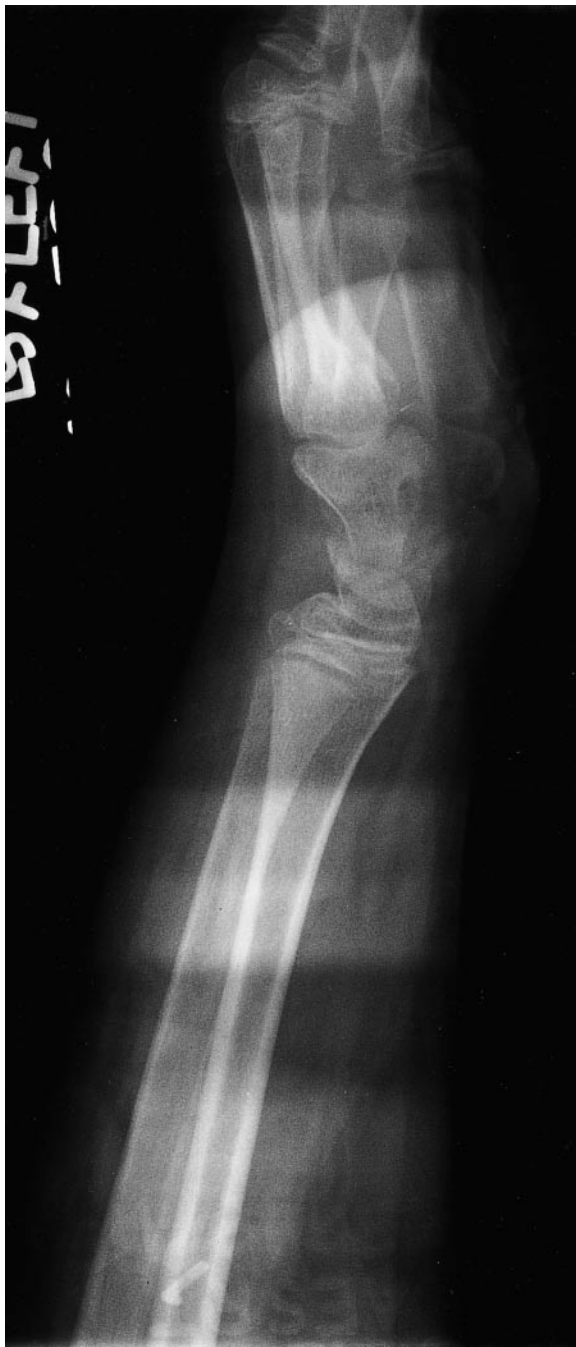
Figure 6. Plate reader artefact. This artifact occurred because the plate reader loaded two imaging plates (IPs) in a single cassette. After an exposure, the bottom IP was extracted, read and replaced as usual, leaving the top IP to be exposed numerous times. Artefact remedy: double-loaded cassettes will be discovered during routine IP cleaning. If a cassette containing two IPs is discovered, the IPs should be erased before being put back into use.

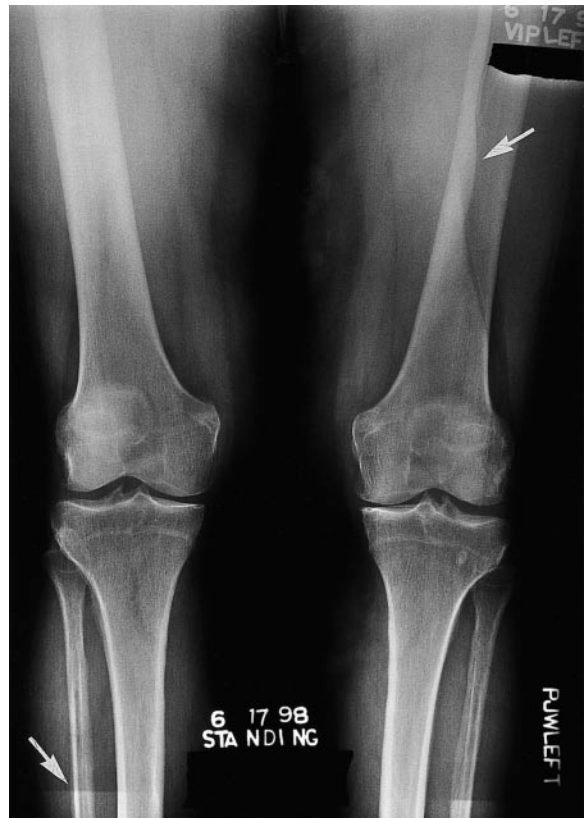
Figure 7. Plate reader artefact. This bilateral knee image was spoiled when the incorrect erasure setting was used to eliminate a previous femur image. Evidence of this is the residual image of the lead marker in the top corner of the image, the tissue line from the previous image (upper arrow) and the additional line of collimation along the bottom of the image (lower arrow). Artefact remedy: radiographers must select the correct erasure setting according to the type of exposure that has occurred.

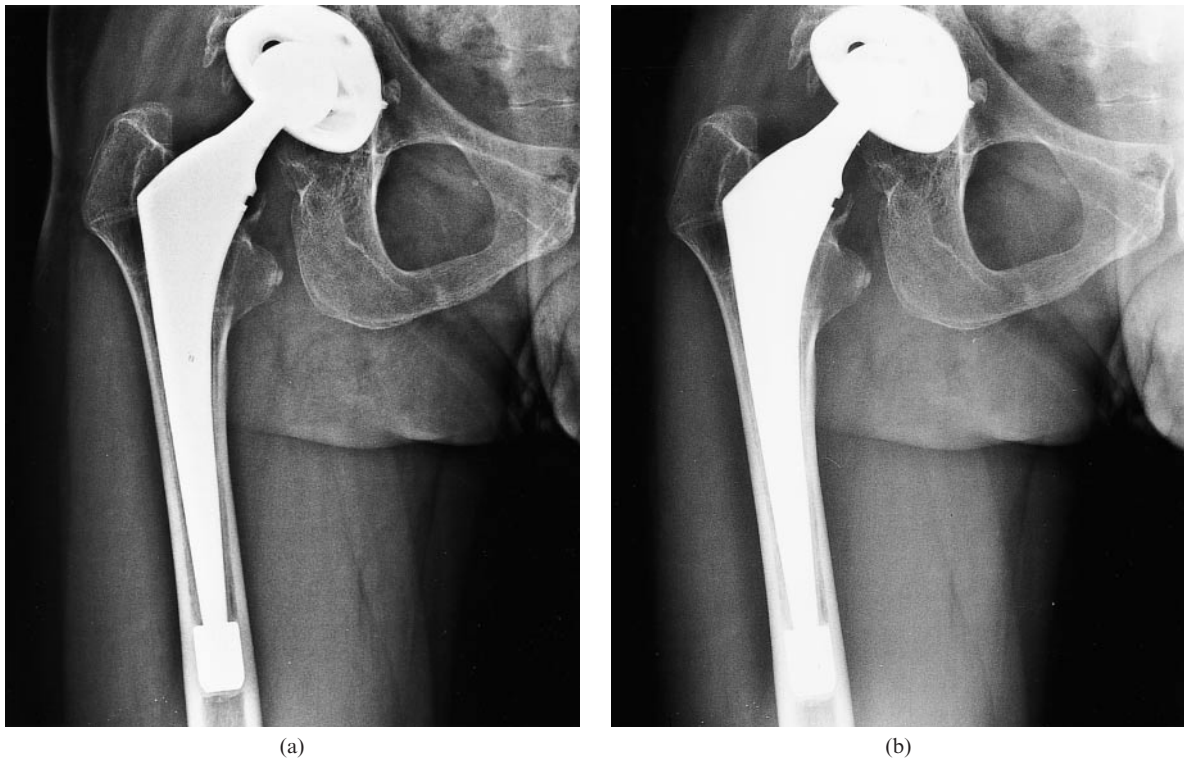
Figure 8. Image processing artefact. (a) When too large a kernel size is selected for image enhancement, artefacts like the black halo surrounding the prosthesis can create the appearance that the prosthesis is loose. (b) The same image as (a) processed with a smaller kernel size.

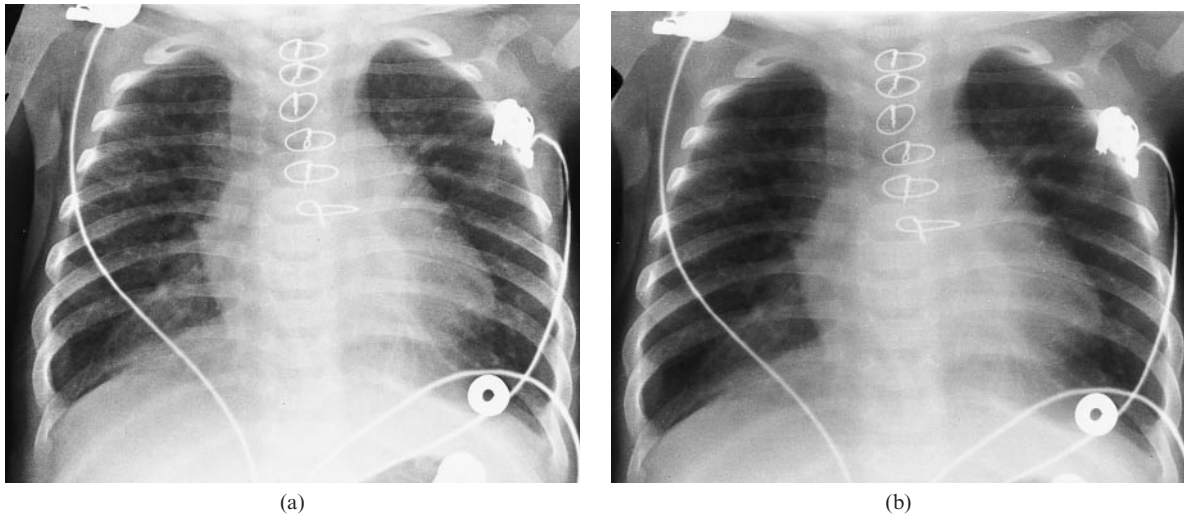
Figure 9. Image processing artefact. (a) Edge enhancement was increased from the default level for this paediatric chest image. Notice the marked increase in lung markings, which could indicate interstitial infiltrates. (b) The same image processed with normal edge enhancement. Artefact remedy: select a standard set of image processing parameters, especially for frequency and edge enhancement, with the help of applications specialists. Once a standard set of processing parameters are selected, post-processing changes should not be needed frequently.

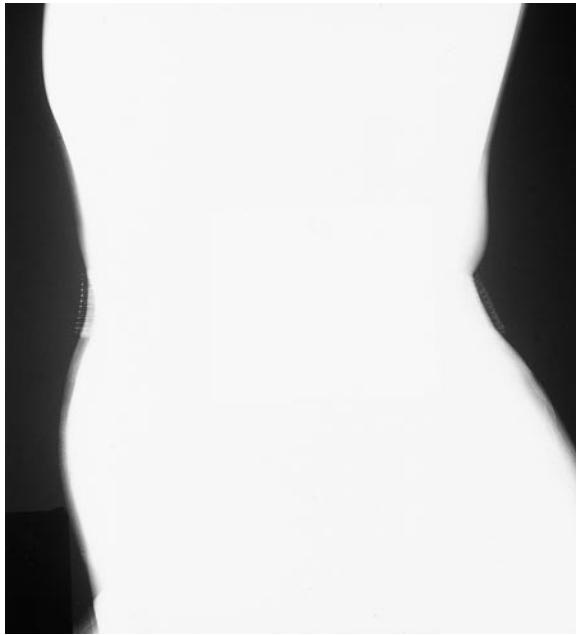
Figure 10. Image processing artefact. Owing to lack of primary beam collimation on this lateral lumbar spine, the amount of unattenuated radiation striking the imaging plate (IP) (anterior and posterior to the patient) altered the histogram so that it was outside the normal range for that body part selection. Artefact remedy: use the smallest IP practicable and collimate the beam to the body part. This is particularly important on small or slim patients.

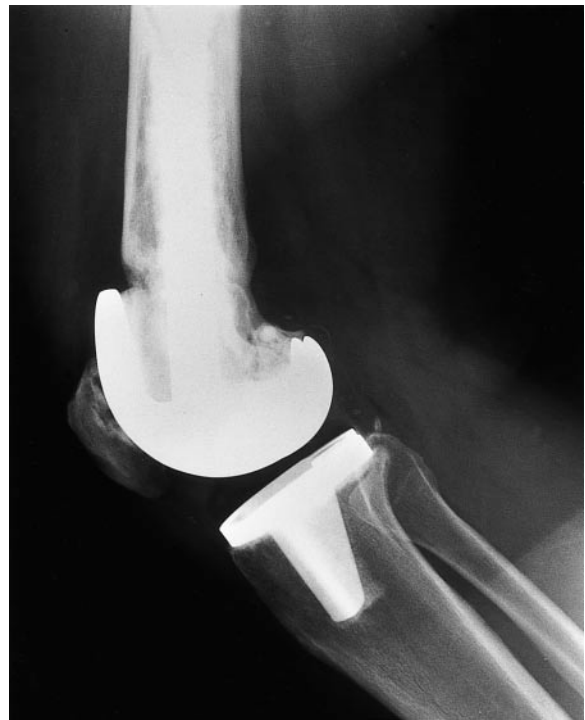
Figure 11. Image processing artefact. The prosthesis in this knee adds too many extreme pixel values to the image histogram. This results in an image where the difference between prosthesis and glue, or glue and bone is not well demonstrated. Artefact remedy: in computed radiography systems that provide different modes of operation, use of a different image processing mode will alleviate this problem. For example, a semi-automatic or fixed mode will cause the image histogram to be analysed differently from a fully automatic mode and will produce a more acceptable image in cases such as this.

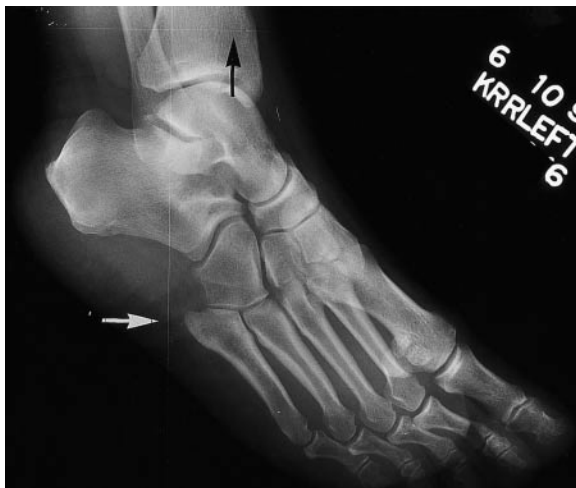
Figure 12. Laser printer artefact. This oblique foot image demonstrates two different artefacts. The fine white line (black arrow) running parallel with the long dimension of the film is an artefact from the laser printer. The line running perpendicular to the long dimension of the film (white arrow) is caused by dirt on the light guide of the photomultiplier tube in the plate reader, as in Figure 5. Artefact remedy: service personnel can use a camel hair lens brush to clean the mirror.

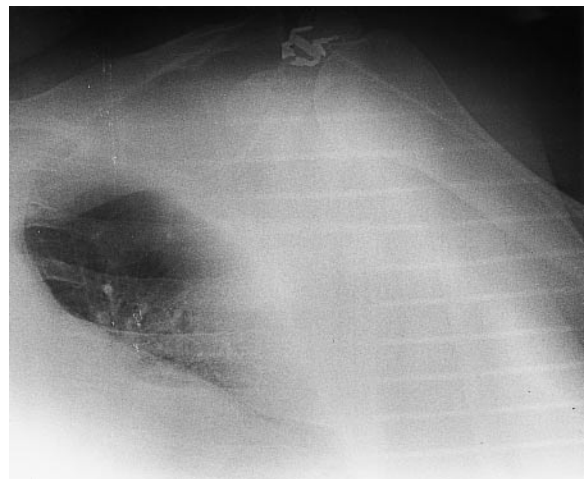
Figure 13. Operator error. A wire mesh cart loaded with unexposed imaging plates (IPs) was placed too near a source of scatter radiation. Because of the high sensitivity of the phosphor to scatter, exposure that may have been minimally seen on a film/screen image was well demonstrated on this portable image. Artefact remedy: protect IPs from sources of scatter radiation. Erase IPs that have been unused for an unknown period of time. One vendor recommends that IPs be erased if left unused for more than 8 h [5]. We have had good results using 1 week as the time limit.

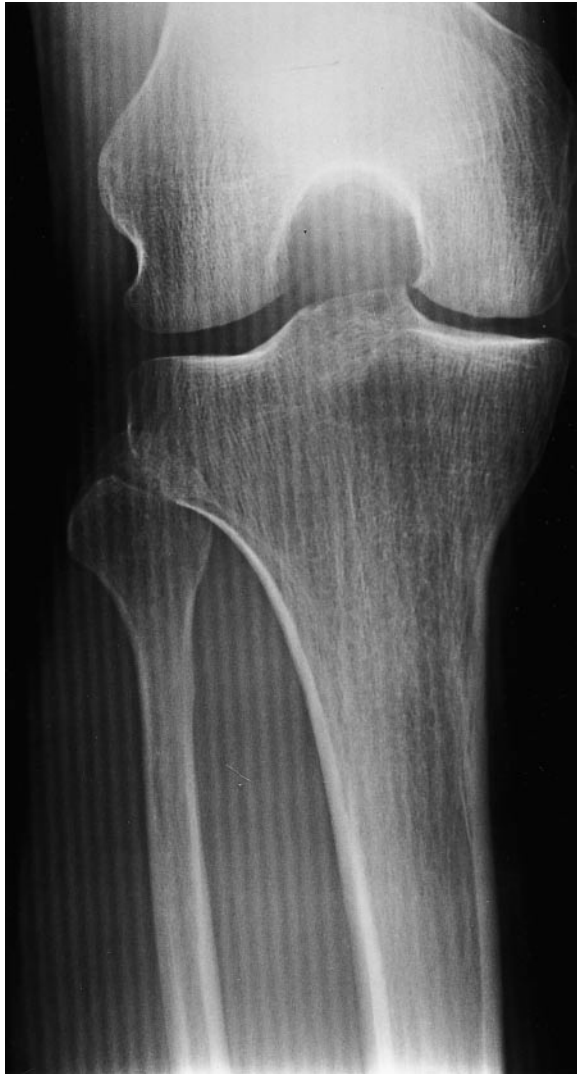
Figure 14. Operator error. The moiré pattern seen in this knee image was caused by using a grid with a frequency of 33 lines cm^{-1} , which was oriented with the grid lines parallel to the plate reader's scan lines. Artefact remedy: use grids with no less than 60 lines cm^{-1} . In addition, grid lines should run perpendicular to the plate reader's laser scan lines.

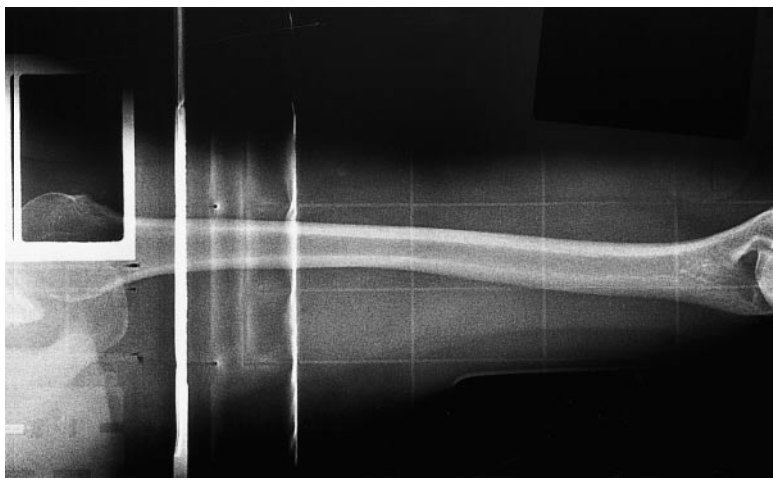
Figure 15. Operator error. This axillary shoulder was exposed through the back of a cassette. Artefact remedy: be sure radiographers are well educated about how to use the entire computed radiography system.
